EUROCOPTER CANADA LIMITED

Required maintenance for the Enlarged Vertical Reference Window Installation
(P/N 350-201154).

Aircraft with the subject modification embodied in accordance with TCCA STC. No. SH06-12
or any relevant foreign approvals.

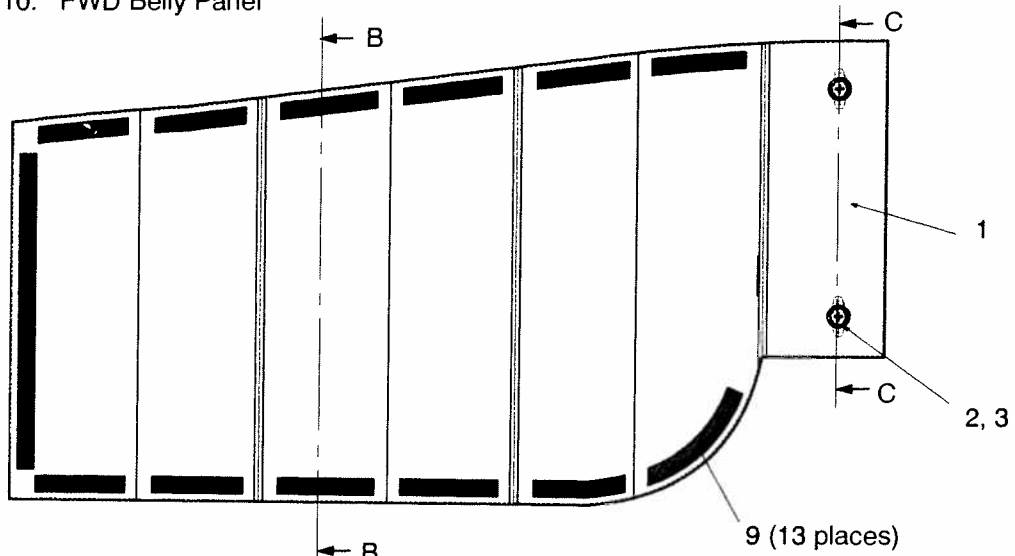
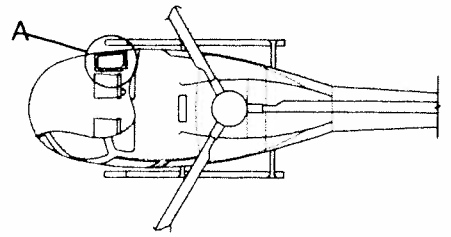
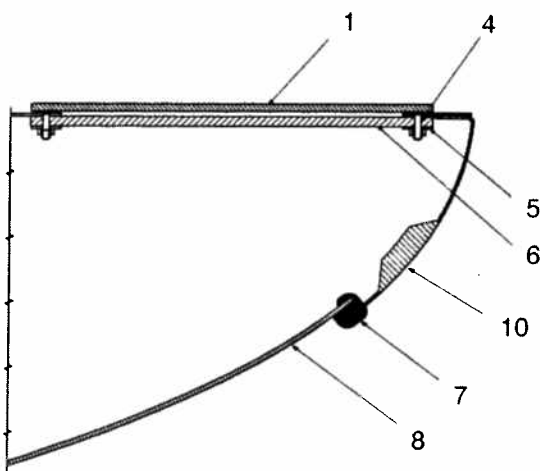
Item	Description
1.	Floor Window Cover
2.	Screw
3.	Washer
4.	Countersunk Screws
5.	Floor Window Backing Plate
6.	Floor Window
7.	Window Channel Seal
8.	Belly Panel Window
9.	Velcro
10.	FWD Belly Panel

DETAIL A

SECTION B - B
(90° ROTATED)

ITEM	INSPECTION OR MAINTENANCE WORK	CORRECTIVE ACTION
A	- Inspect velcro, item 9 on Floor Window Cover, item 1, in Figure 2, for: a. wear (tears, areas have become worn)	a. Wear is not permitted, if wear is evident, replace Velcro in accordance with EC MTC, Volume 3, Chapter 20.03.04.406.
B	- Inspect floor window, item 6 and belly panel window, item 8, in Figure 2, for: a. cracking or crazing	a. No cracking or crazing is allowed. If cracking or crazing is found replace window. Contact Eurocopter Canada Limited for replacement parts.

ITEM	INSPECTION OR MAINTENANCE WORK	CORRECTIVE ACTION
C	<ul style="list-style-type: none"> - Visually inspect window channel seal, item 7, between FWD belly panel, item 10, and belly panel window, item 8, in Figure 2, for: <ul style="list-style-type: none"> a. cuts and cracking 	<ul style="list-style-type: none"> a. If cuts and cracks are evident, replace window seal in accordance with EC, MET, Volume 3, Chapter 52.00.00.401
D	<ul style="list-style-type: none"> - Visually inspect FWD belly panel Mod, item 1, and intermediate belly panel MOD, item 2, in Figure 3, for: <ul style="list-style-type: none"> a. general condition 	<ul style="list-style-type: none"> a. If cracking, delamination or debonding is found, repairs must be performed by qualified composite personnel. Repairs may be accomplished in accordance with EC MTC, Volume 3, Chapter 20.03.07.101, or AC 43.13-1B, Chapter 3, Section 1. (Refer to Figures 6, 7, 8, and 9 for Composite Lay up).

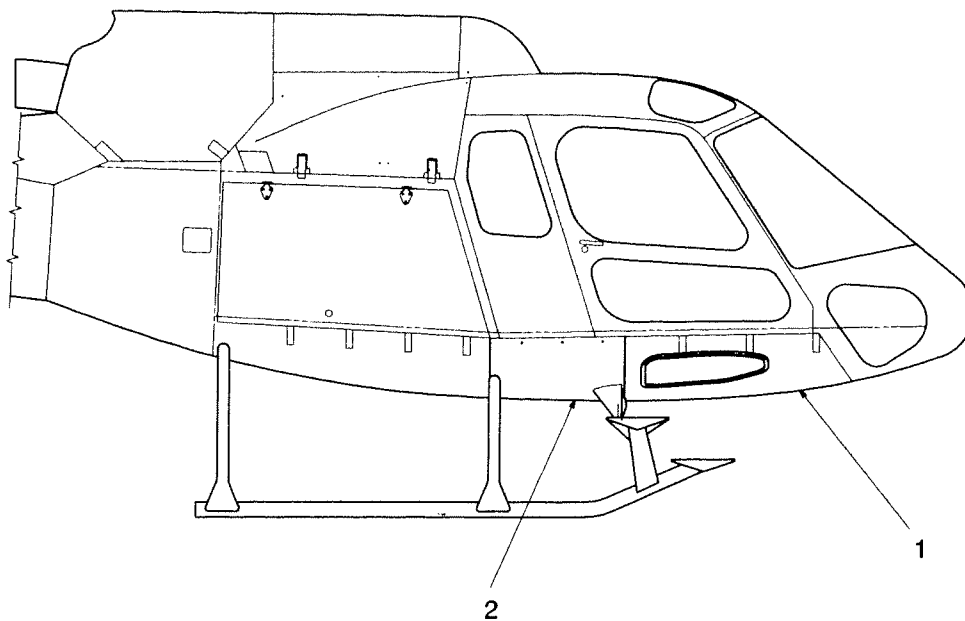
Figure 3 Forward and Intermediate Belly Panels

Item	Description
1.	Forward Belly Panel Mod
2.	Intermediate Belly Panel Mod

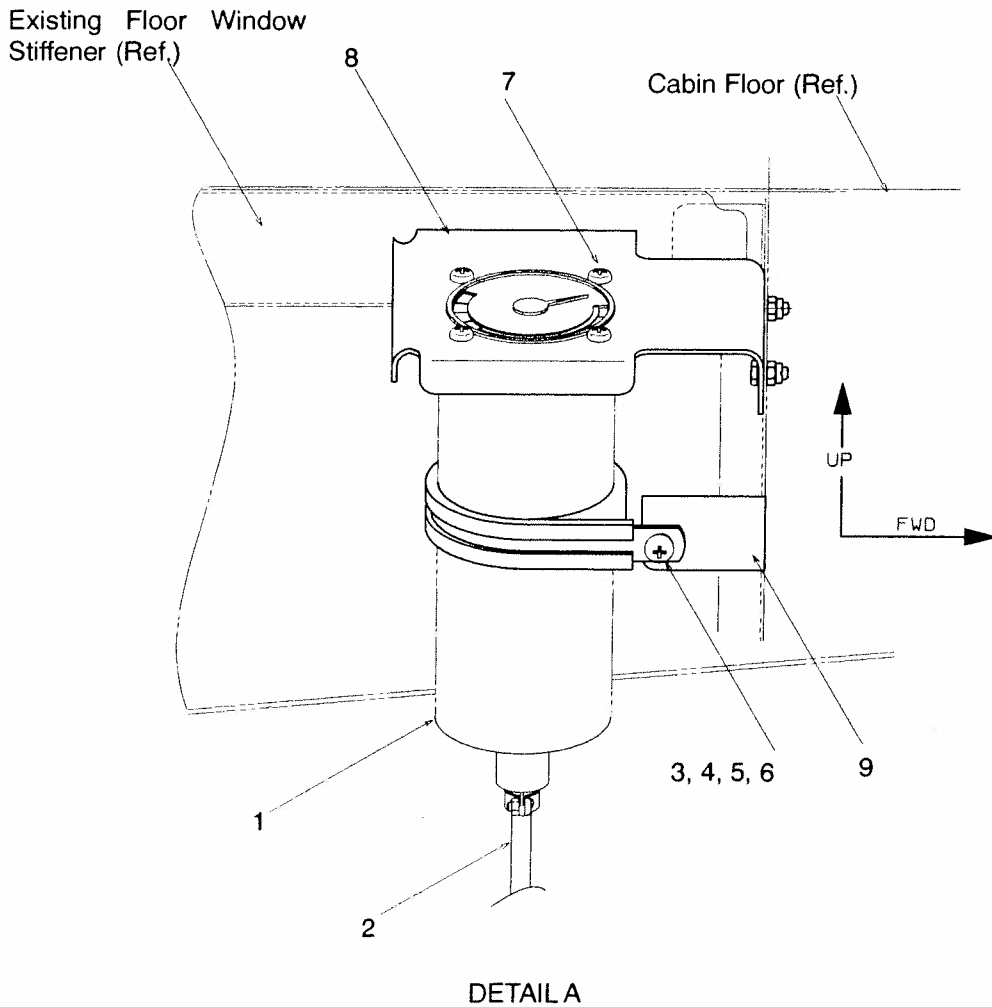
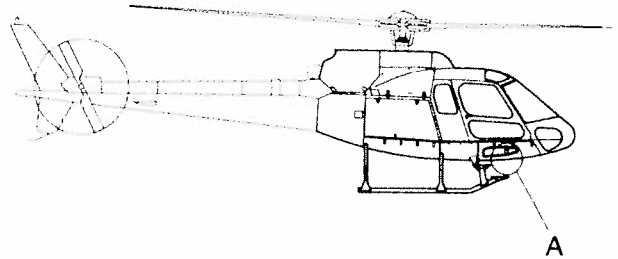
Figure 7 Floor-Mounted Torque Indicator Option

Item	Description
1.	Torque Indicator
2.	Wiring Harness
3.	Screw
4.	Washer
5.	Nut
6.	Clamp
7.	Screw
8.	Mounting Bracket
9.	Support Bracket

Note For the AS 350 B2 without VEMD only

- b) Remove belly panel window (8).
- 3) Optional Floor Mounted Torque Meter Installation (AS 350 B2 without VEMD only, refer to Figure 7 if aircraft utilizes original installation or Figure 8 if aircraft has reinforced floor).

- 1) Floor Mounted Torque Meter Installation if installed (AS 350 B2 without VEMD only, refer to Figure 7 if aircraft utilizes original installation or Figure 8 if aircraft utilizes alternative installation).

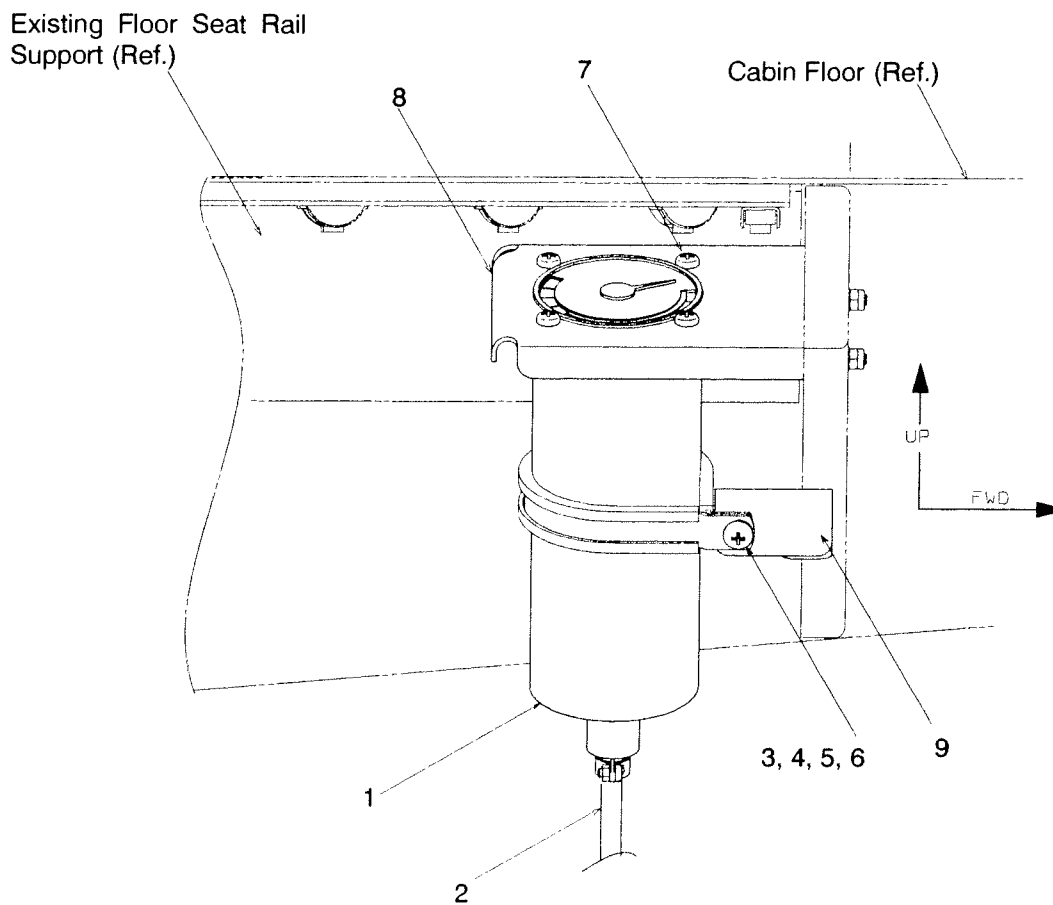
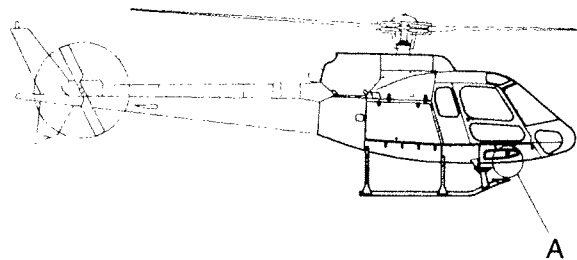
Figure 8 Floor-Mounted Torque Indicator Option
(aircraft with reinforced floor shown)

Item	Description
1.	Torque Indicator
2.	Wiring Harness
3.	Screw
4.	Washer
5.	Nut
6.	Clamp
7.	Screw
8.	Mounting Bracket
9.	Support Bracket

DETAIL A

Note For the AS 350 B2 without VEMD only

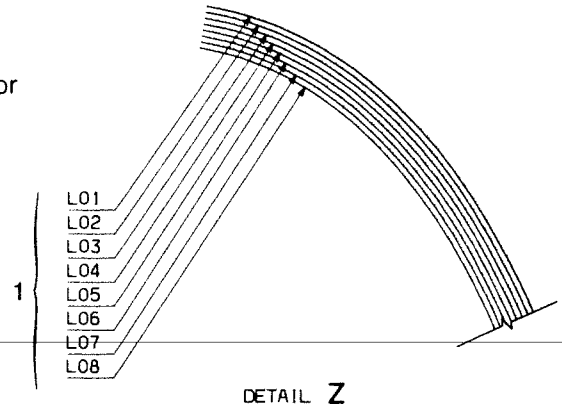
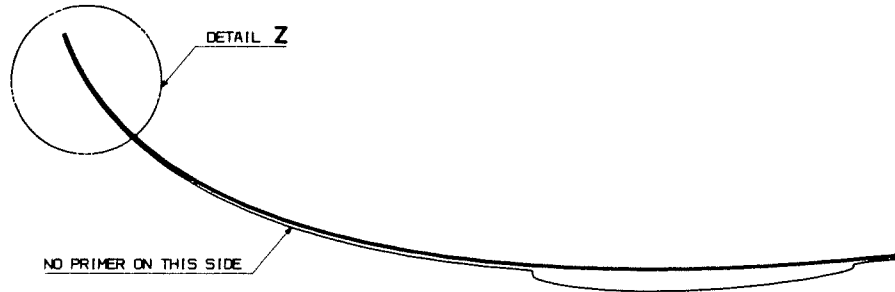
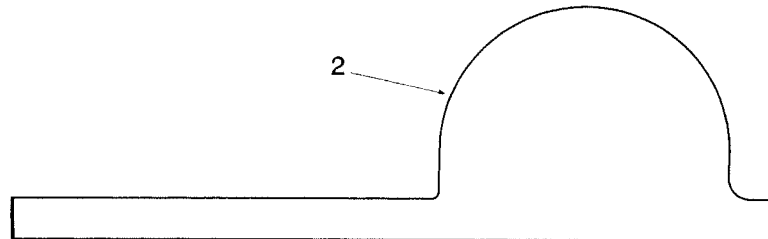
LAY-UP PLAN

| 1. | Fiberglass Prepreg P/N CYCOM919/7781 or E761-7781 |
| 2. | Landing Light Filler |

10	L08	0°			1
10	L07	90°			1
10	L06	+/-45°			1
10	L05	90°			1
10	L04	0°			1
10	L03	+/-45°			1
10	L02	90°			1
10	L01	0°			1
ITEM NO	LAYER NO	FIBRE OR WARP DIRECTION	LENGTH (MM)	WIDTH (MM)	PLY QUANTITY /APPL. TO
