Dynamic Components: Repair & Overhaul and Machining

EUROCOPTER
CANADA

Eurocopter Canada's level I-IV Repair and Overhaul (R&O) department is certified for all dynamic components, mechanical assemblies and hydraulic systems for the EC120, AS350, AS355, EC130, BO105 and BK117.

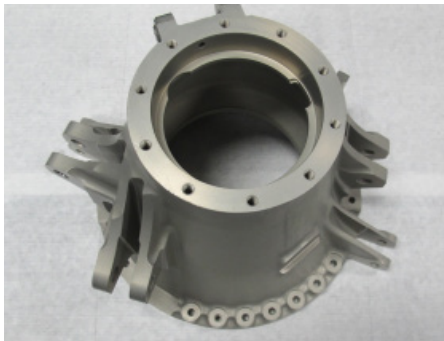
Model EC120
Part Upper Housing
Part # C632A1111-XXX
Repair Bore and bush

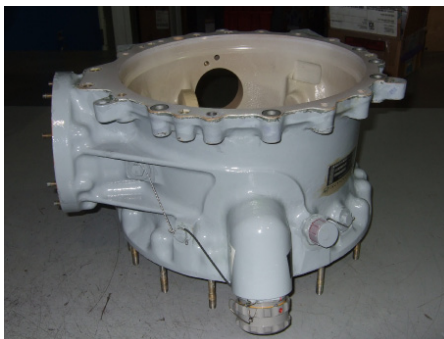
Model EC120
Part Center Housing
Part # C632A2116-XXX
Repair Corrosion in holes

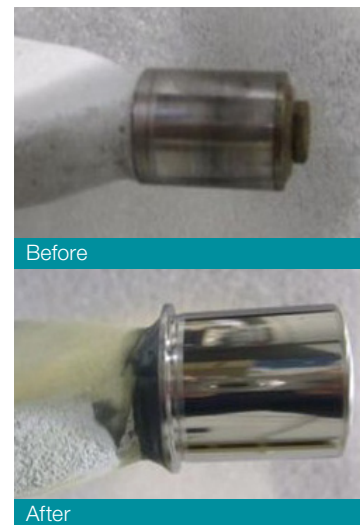
Model	AS350 / AS355 / EC130
Part	Starflex Bushing
Part #	350A31-1917-XX
Repair	Removal of worn-out bushings Installation of new bushings Certification

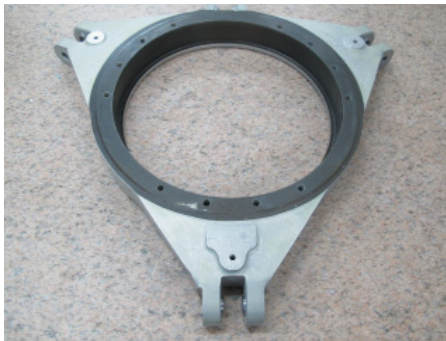
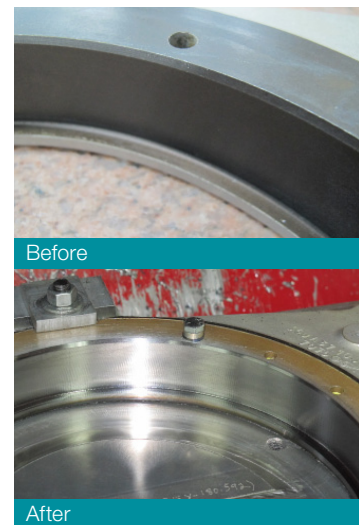
Model AS350
Part Rotating Star
Part # 350A37-1003-XX
Repair Corroded surface and bore

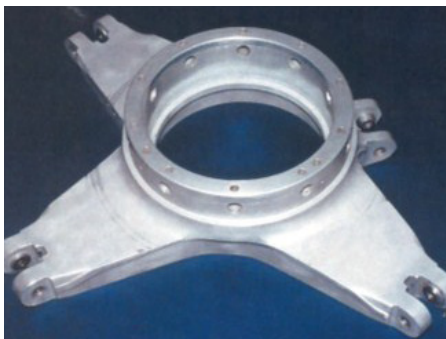
Model AS350 / AS355 / EC130
Part Star, non-rotating
Part # 350A37-1002-XX
Repair - Worn mounting ears / stirrups
- Bore and bush

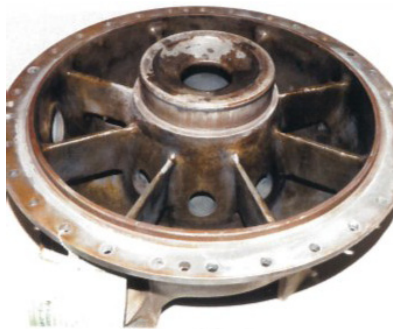
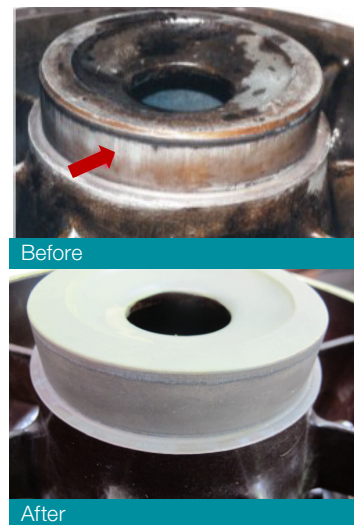
Model AS350 / AS355 / EC130
Part Lower Case
Part # 350A32-3119-XX
Repair

- Worn/undersize bearing mounting diameter
- Bi-directional faces
- Flanges / holes

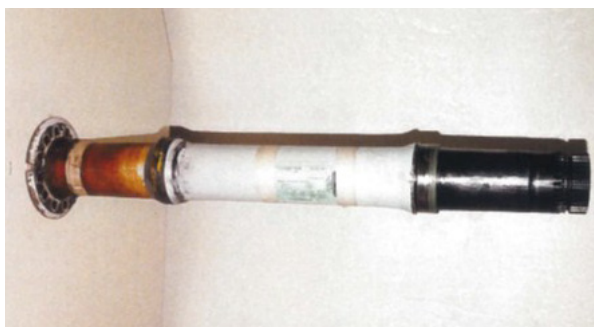
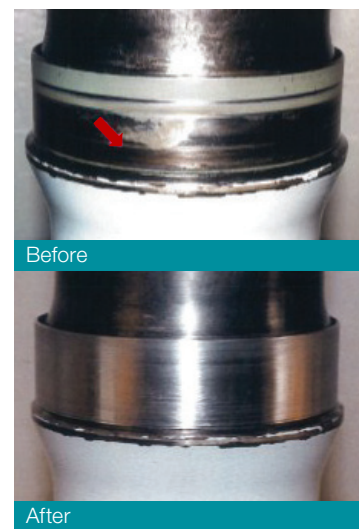
Model AS350 / AS355 / EC130
Part Main Mast (Timken or 4 Contact)
Part # 350A37-1076-XX / 350A37-1290-XX
Repair Worn/undersize bearing sleeve

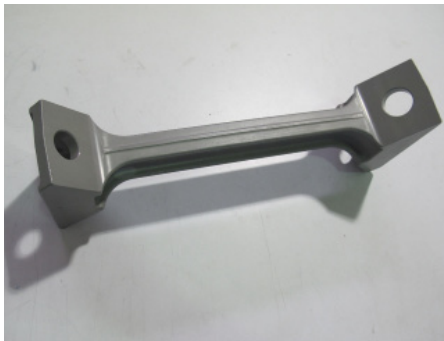
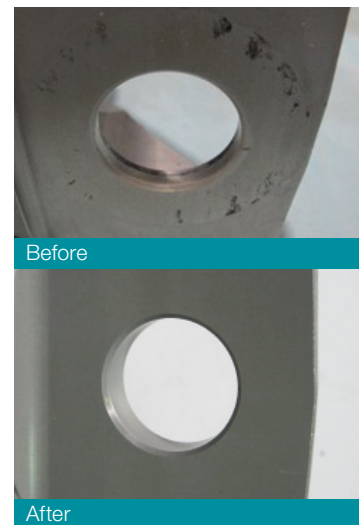
Model AS350
Part Transmission Cross Beam
Part # 350A38-1018-XX
Repair Bore and bush

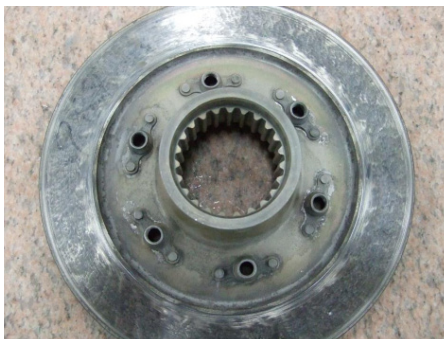
Model AS350 / AS355 / EC130
Part Brake Disc
Part # 350A32-3088-20
Repair Wear on surface

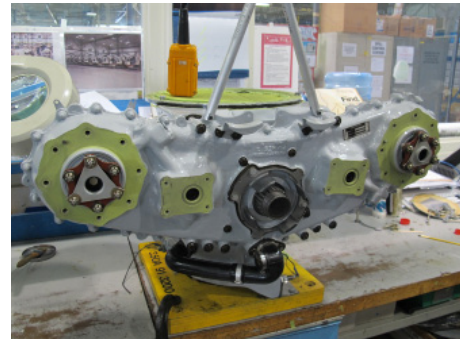
Model	AS355
Part	Combining Gearbox
Part #	355A0210-XX / 355A0200-XX
Repair	<ul style="list-style-type: none">- Corrosion- Worn / oversized bearing bores

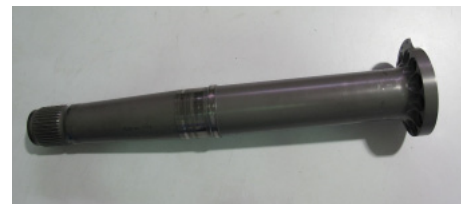
Model	BO105
Part	Mast
Part #	4619-305-XXX
Repair	<ul style="list-style-type: none">- Corrosion on mounting face- Replacement of mast momments / bridge

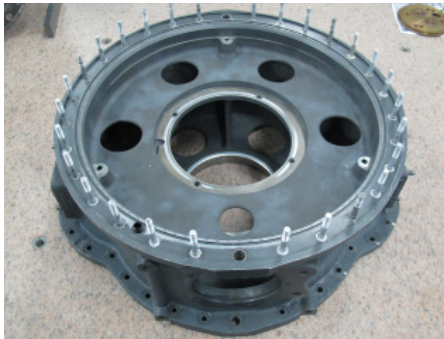
Model BO105
Part Transmission Center Case
Part # 4638-201-0030
Repair

- Tail rotor bore; fan bore; axillary bore
- Seal seat
- Corroded mounting holes and flange surface

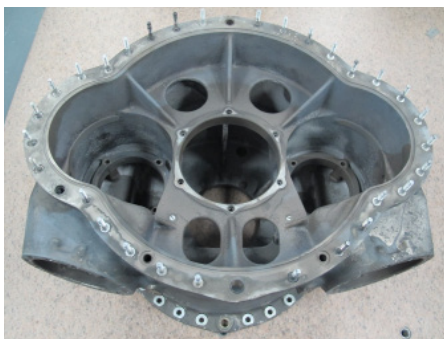
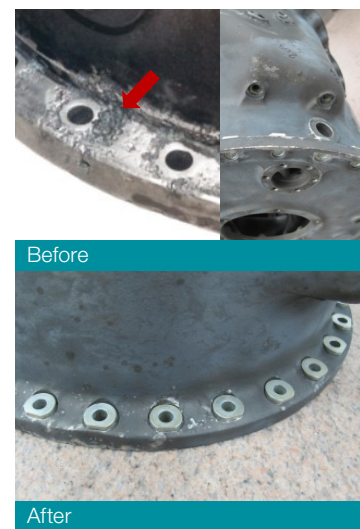
Model BO105 / BK117
Part Lower Housing
Part # 4638-201-XXX
Repair

- Corroded flange surface
- Bolt holes

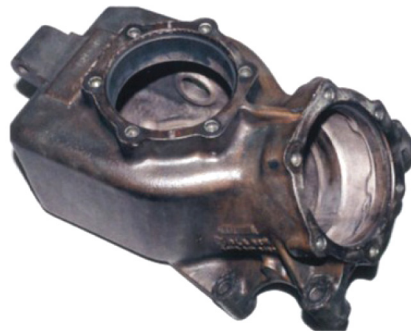
Model BO105
Part Intermediate Gearbox Housing
Part # 4619-310-XXX
Repair

- Corroded chamfer surfaces
- Corroded bore surfaces
- Mounting lugs

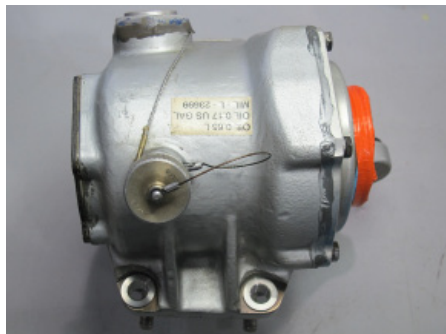
Model BO105 / BK117
Part Tail Rotor Gearbox Assembly
Part # 4639-310-XXX
Repair

- Oversize bolt holes
- Removal of corrosion and bush
- Bore surface
